SAND98-1016

Damage Tolerance Assessment of Bonded Composite Doubler Repairs for Commercial Aircraft Applications

Dennis Roach

Sandia National Laboratories

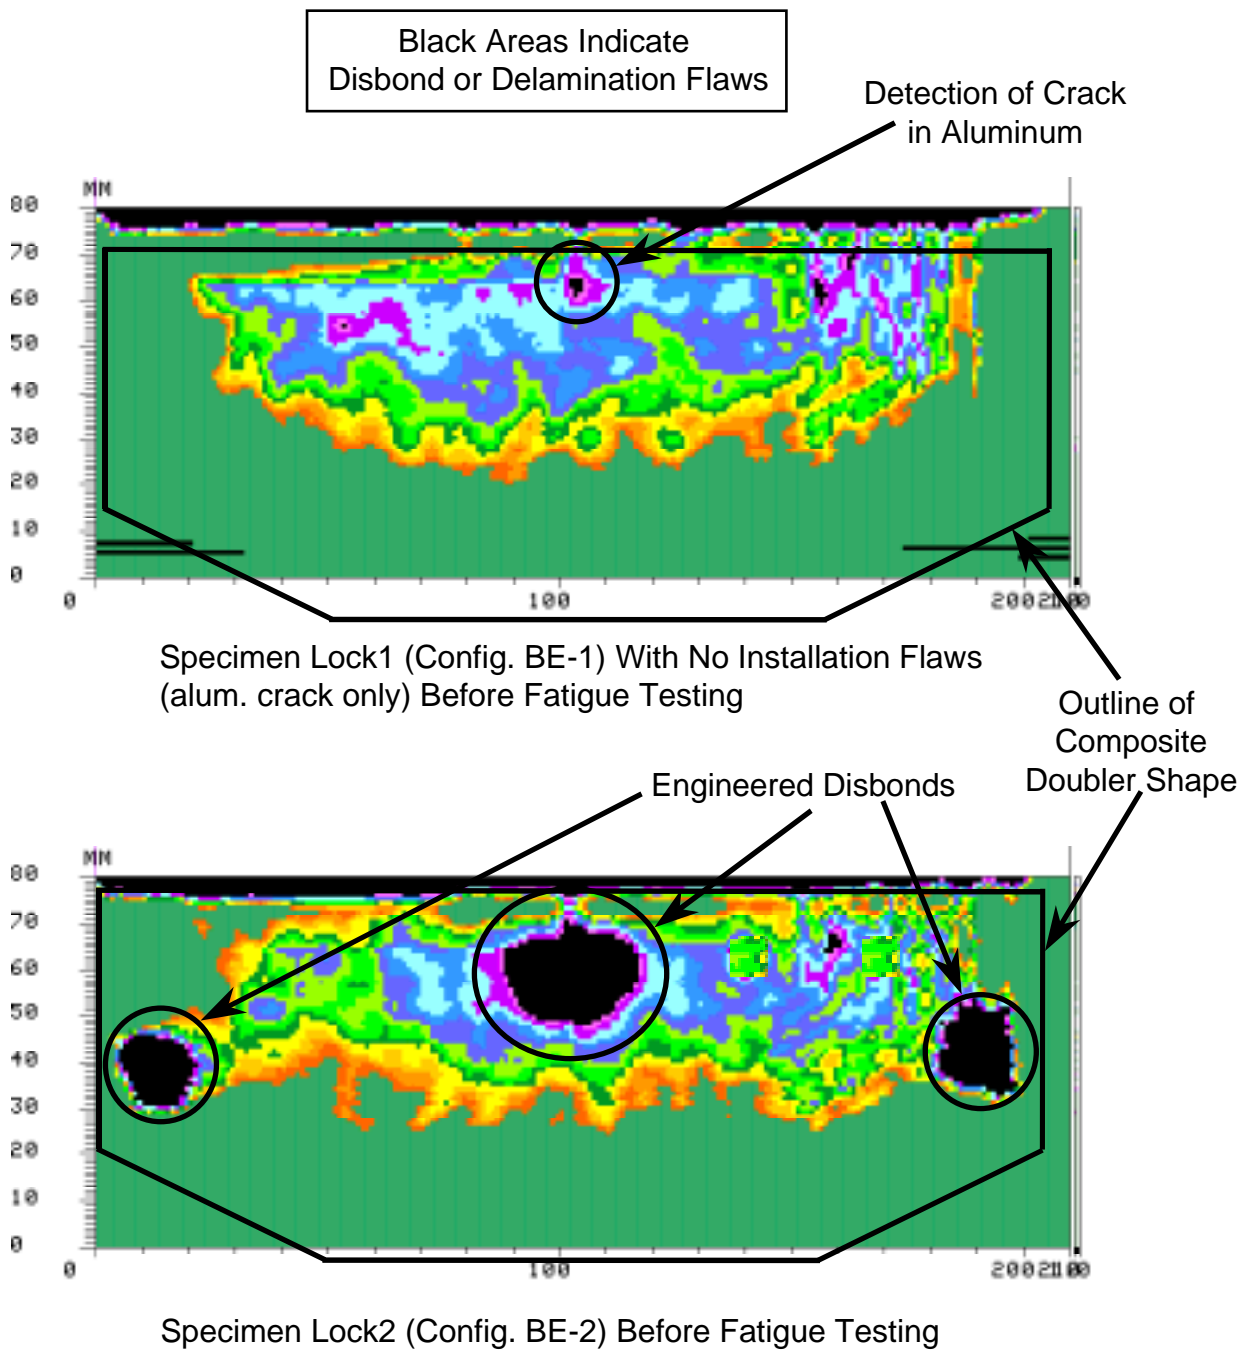
Figure 28: Fatigue Specimens Lock1 and Lock2 Flaw Profiles Before Fatigue Testing; Specimens Were Loaded to Failure After Fatigue Testing

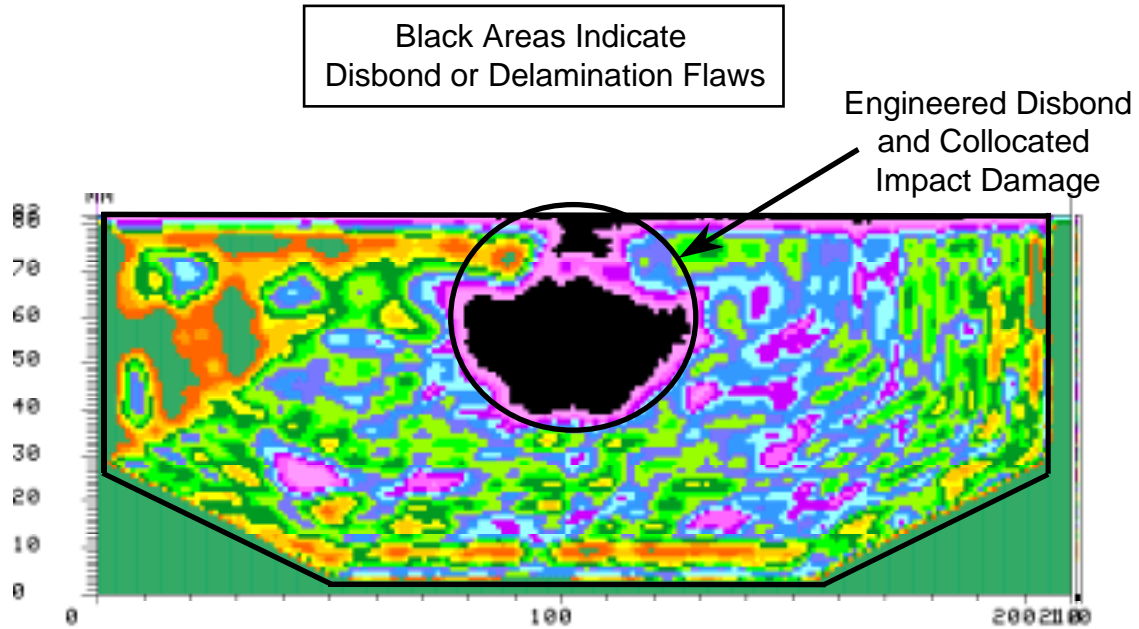
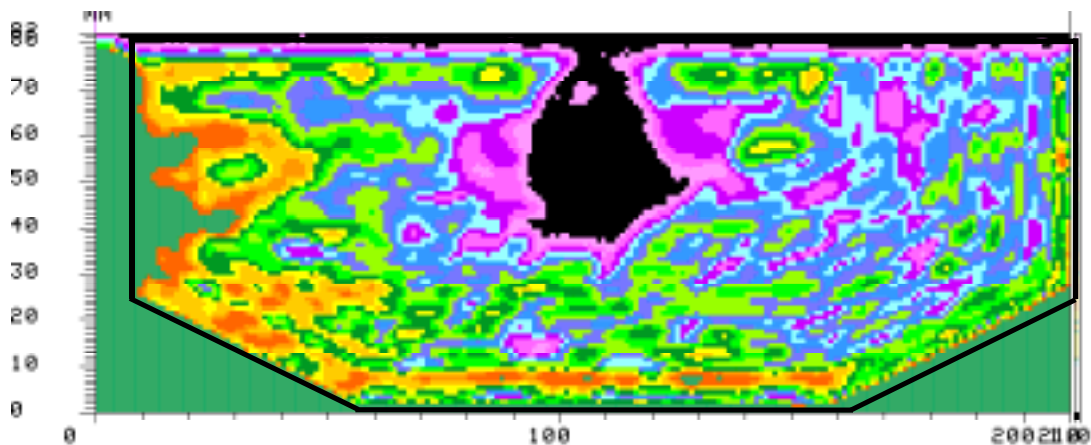
**Figure 29: Fatigue Specimens Lock11 and Lock12 (Configuration BE-8)
Show Consistency of Engineered Flaw Profiles and
Ability to Detect Flaws Via Ultrasonic Inspections**

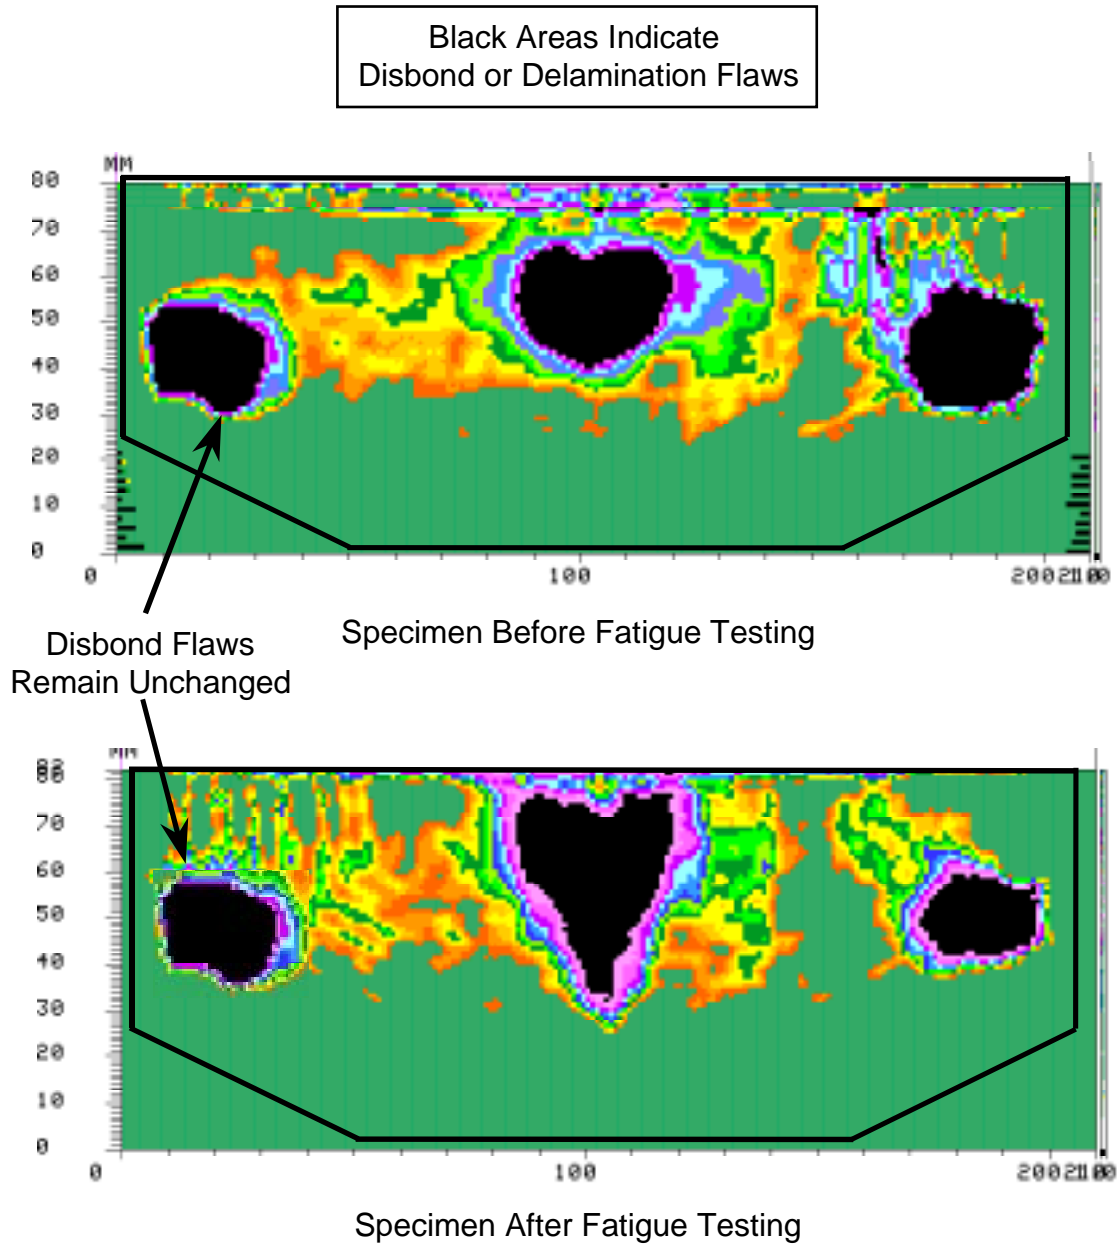
Figure 30: Fatigue Specimen Lock3 (Configuration BE-3) Flaw Profile Before and After 144,000 Fatigue Cycles

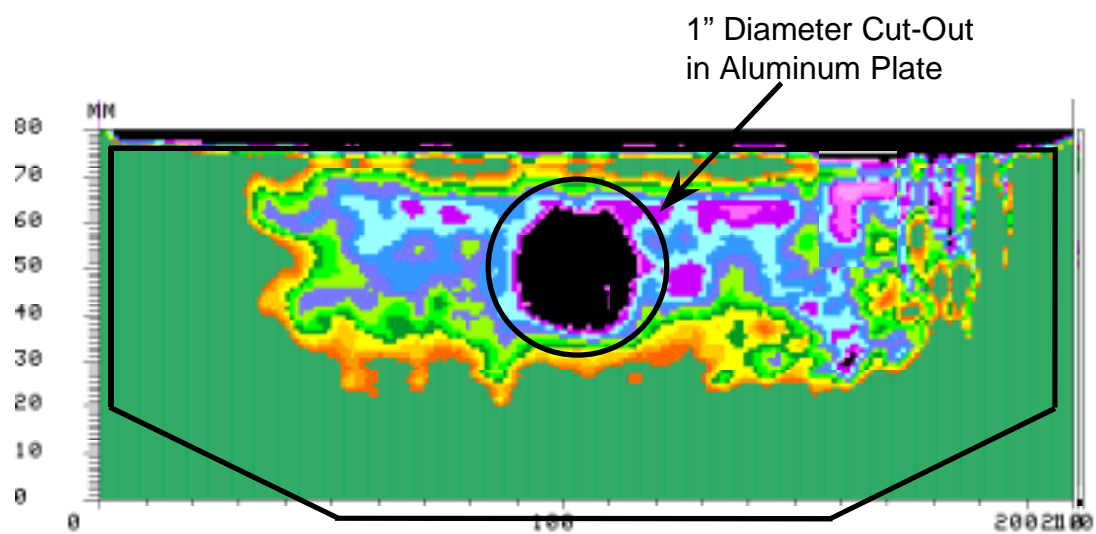
Figure 32: Fatigue Specimen Lock5 (Configuration BE-5) Flaw Profile Before and After 180,000 Fatigue Cycles; No Flaw Growth After Five L-1011 Fatigue Lifetimes

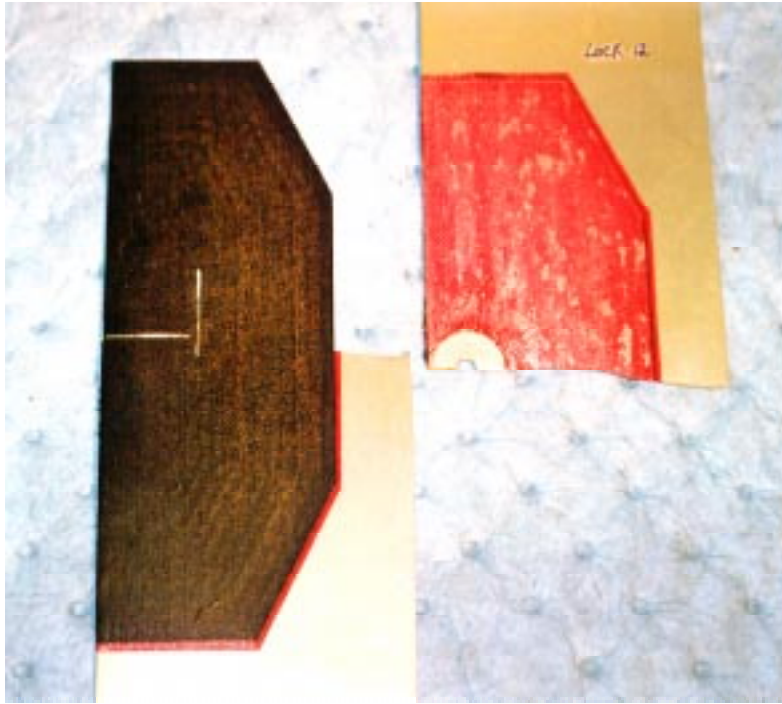
(a) Front View Showing Doubler Intact

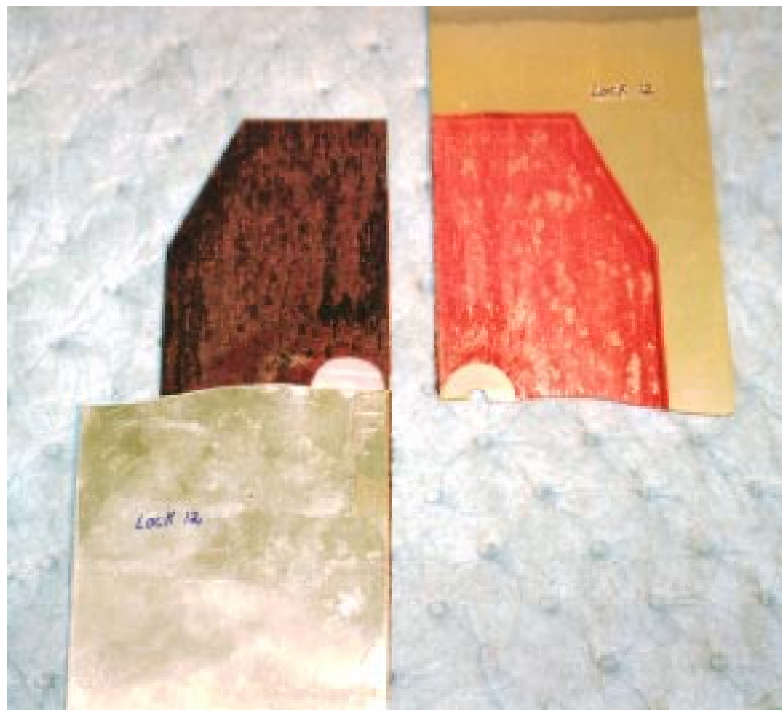
(b) Back View of Doubler/Plate Shows Adhesive on Both Mating Skins

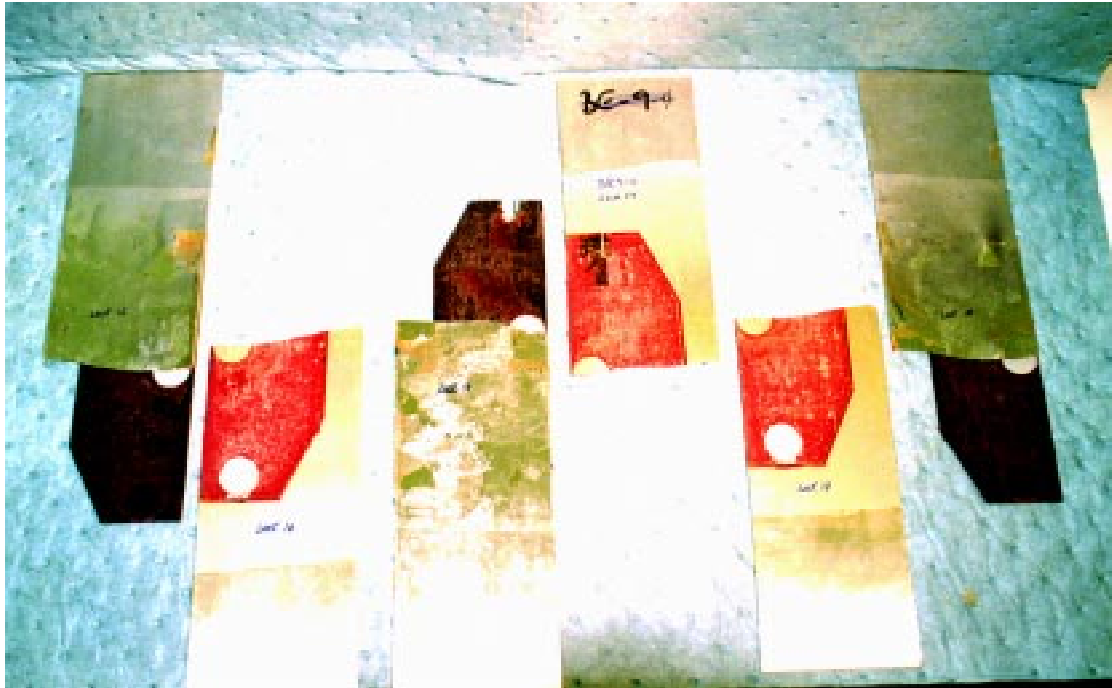
(a) Common Failure in Doubler Specimens

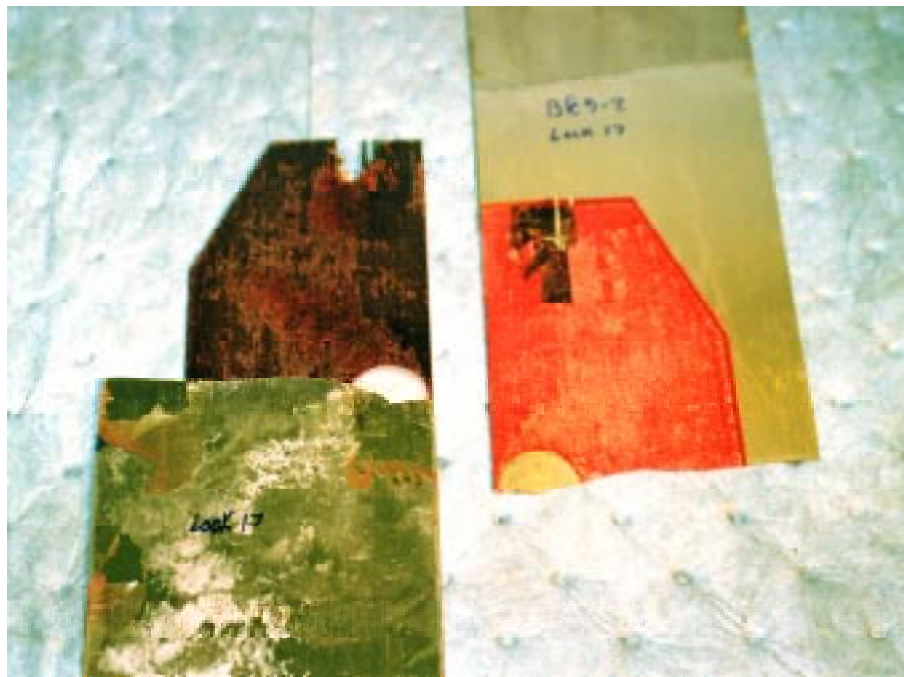
(b) Close-Up View of Doubler Fracture Caused by Impact
